**The Hey Group**

Reference Number CIM 438 Condensation test r0

## **Condensation test**

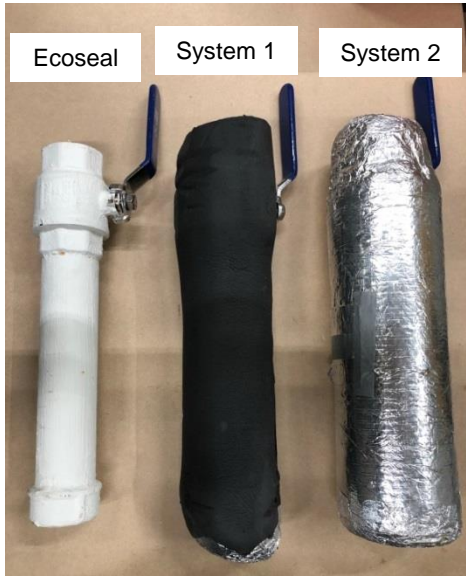
Figure 1 Pipe sections

The Centre for Infrastructure Management (CIM) at Sheffield Hallam University was requested by The Hey Group (from now on referred to as the client) to investigate the formation of moisture condensation on the surface of three pipes covered with their RZ-Ecoseal sealing product and two different pipe insulation systems (from now on referred to as System 1 and System 2), respectively (Figure 1).

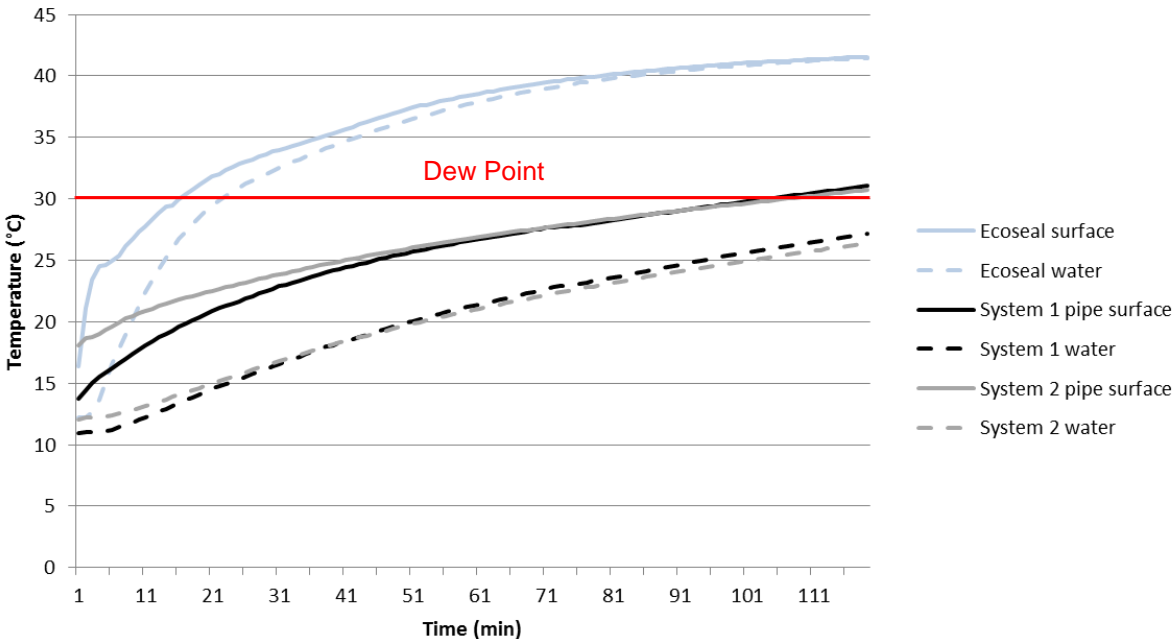
Figure 3 shows the temperatures of the water inside the pipes and of the surface of the pipes during the two hours monitoring period. It can be seen that both pipe surface temperature and water temperature increase at a slower rate for the pipes covered with insulation (System 1 and System 2) than for the pipe sealed with RZ-Ecoseal. The Dew Point at the temperature and relative humidity maintained inside the chamber ( $40\text{ }^{\circ}\text{C}$  and  $60\%$  RH) is estimated to be  $30\text{ }^{\circ}\text{C}$  and is shown by a red line in Figure 3. The dew point is the temperature below which water vapour condenses to form liquid water. This means that when the air in the chamber cools to below  $30\text{ }^{\circ}\text{C}$  through contact with the pipe surface at a temperature below  $30\text{ }^{\circ}\text{C}$ , water will condense on the surface of the pipe.

Figure 3 Water and pipe surface temperature during the two hours monitoring period

These results are in line with the temperature data plotted in Figure 3, which shows that the surface of the pipe sealed with RZ-Ecoseal reaches a temperature above the dew point at around 17 min from the introduction of the pipe in the chamber. The observed condensation disappeared at about 20 min due to the rapid increase of the temperature of the pipe surface. Figure 3 also shows that the temperature of the surface of the pipes covered with Systems 1 and 2 stays below the dew point until about 106 min from the start of the exposure and condensation was still observed at 120 min due to the slower increase of their surface temperatures.

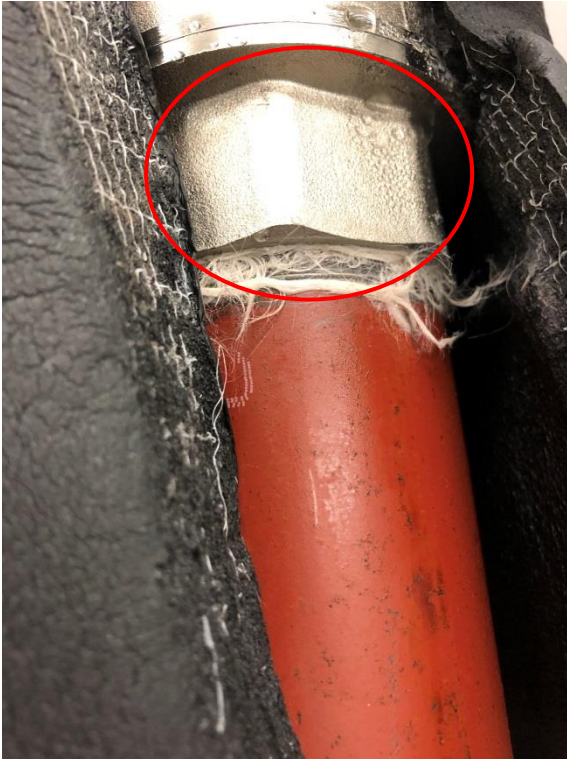
The inspection of the pipe surfaces following the two hours exposure in the chamber revealed the presence of condensation under the insulation systems 1 and 2 (Figures 4 and 5). No condensation was observed on the surface of RZ-Ecoseal at two hours, however, some condensation was observed at 5 min from the introduction of the pipe in the chamber (Figure 6) which disappeared at around 20 min.

**Figure 4** Condensation on the pipe covered with System 1 at the end of the two hours exposure

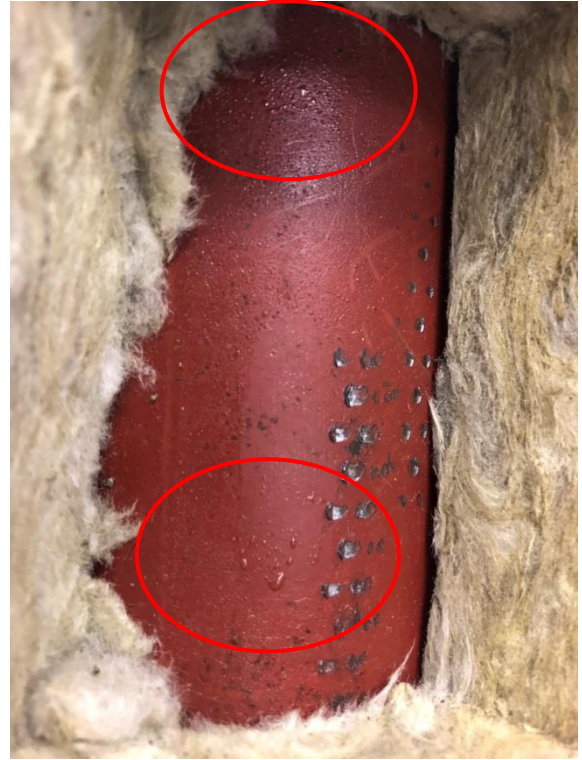
**Figure 5** Condensation on the pipe covered with System 2 at the end of the two hours exposure
